Crumb Rubber Asphalt Demonstration Trials – Final Report

ARRB Project No.: 014173

Prepared for: Tyre Stewardship Australia

May 2022

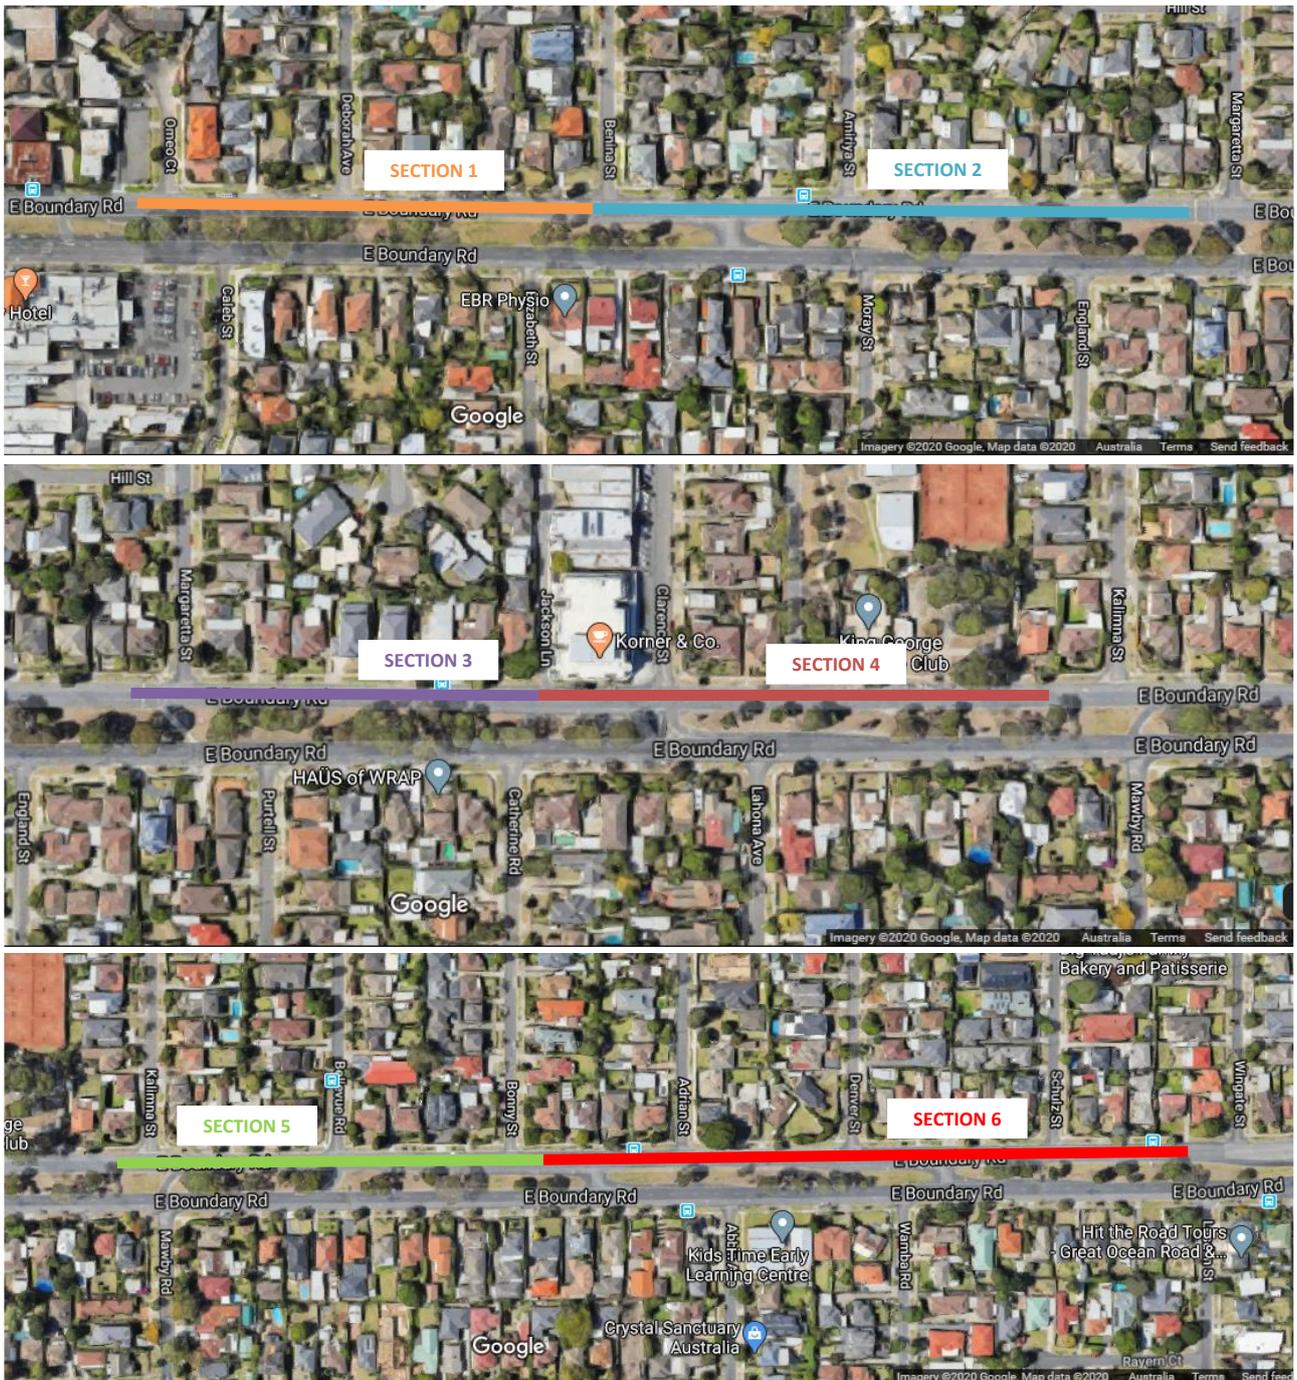
Figure 2.1: Map of trial site sections

A summary of the trial site sections and locations is provided in Table 2.1. The zero-chainage location was 30 m north of Omeo Court. A map view of the trial site sections is provided in Figure 2.1.

Section number	Chainage		Product
	Start (m)	End (m)	
1	0	200	10 mm dense graded crumb rubber asphalt
2	200	447	10 mm stone mastic asphalt (type H) A10E (control)
3	447	647	14 mm gap graded crumb rubber asphalt
4	647	847	10 mm stone mastic crumb rubber (wet mix) asphalt (type N)
5	847	1,200	10 mm stone mastic asphalt (type N) A20E (control)
6	1,200	1,450	10 mm stone mastic crumb rubber (dry mix) asphalt (type N)

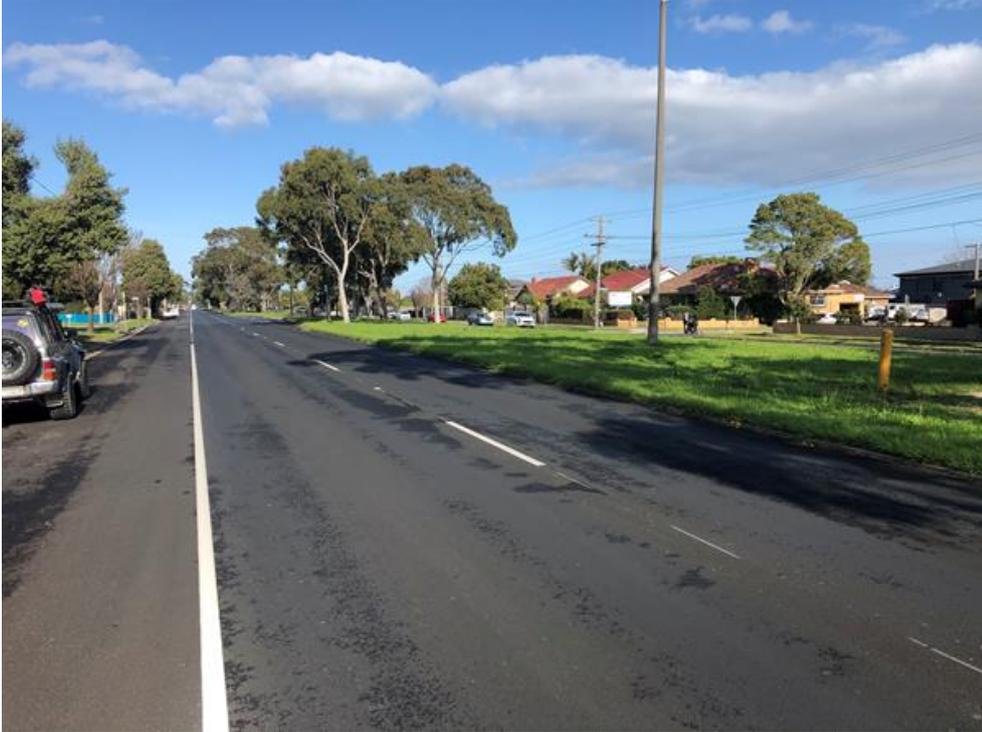
Figure 2.2: Section 1 at 3 months

Section 1 of the trial was laid on 15 March 2020, with a crumb rubber asphalt. The mix is a 10 mm dense graded asphalt, utilising C320 binder modified with 20% crumb rubber. An inspection after three months of trafficking found the asphalt to be performing well (Figure 2.2).

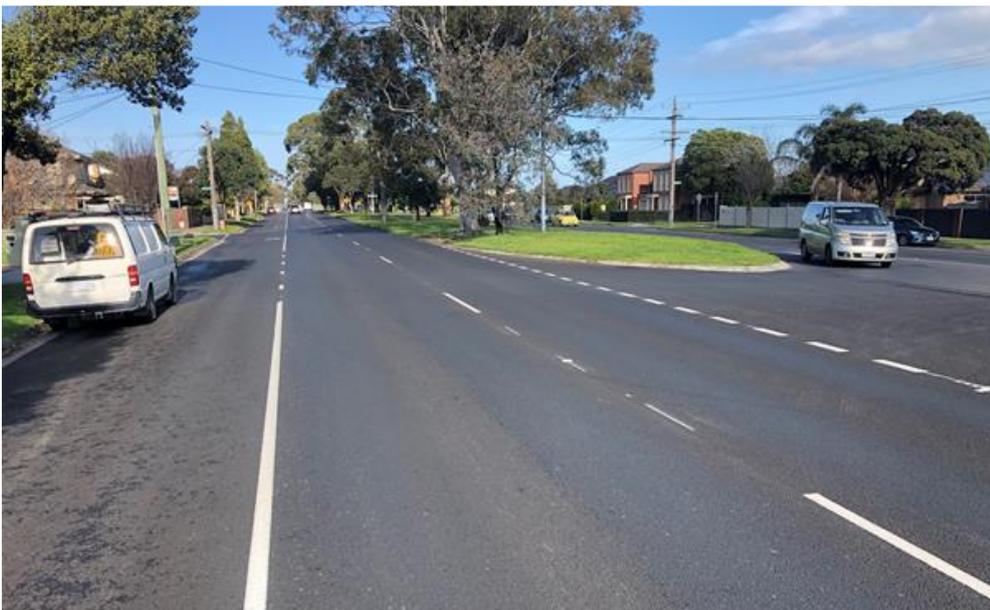
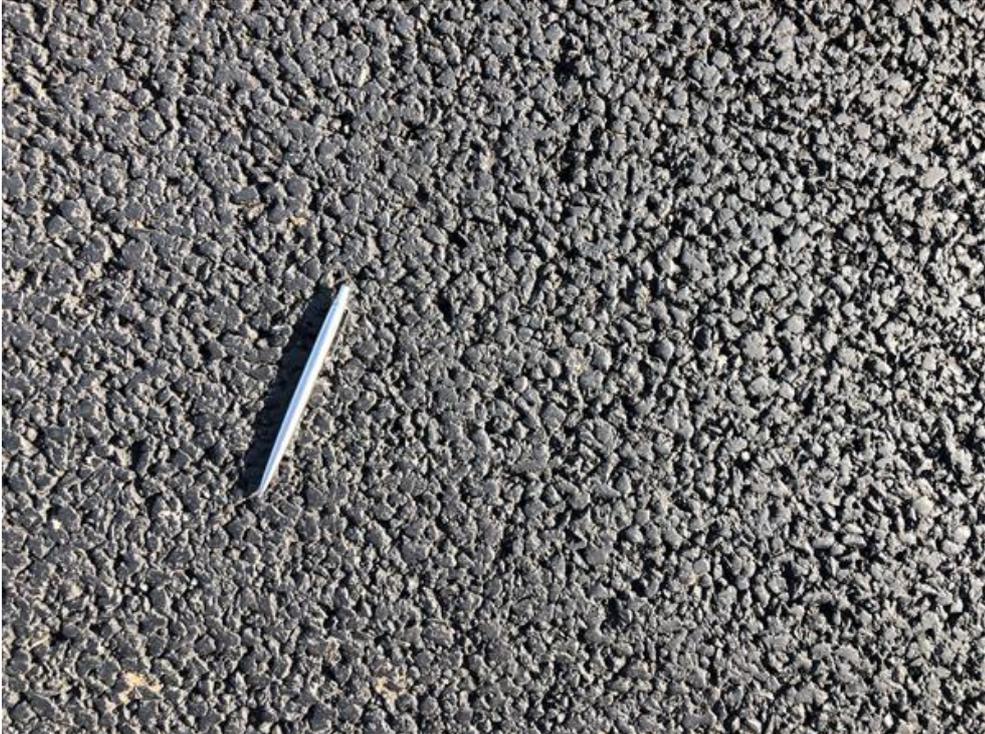
Section 2 of the trial was laid on 16 March 2020, as a control mix. The mix is a 10 mm stone mastic asphalt, type H, utilising A10E binder. An inspection after three months of trafficking found the asphalt to be performing well (Figure 2.3 and Figure 2.4).

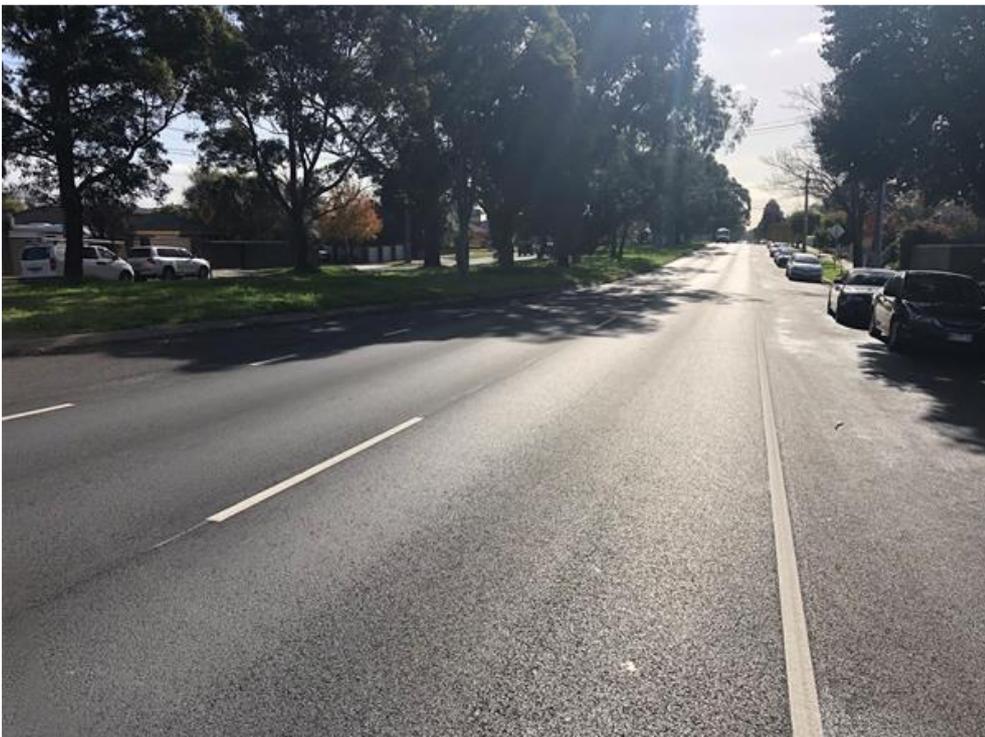
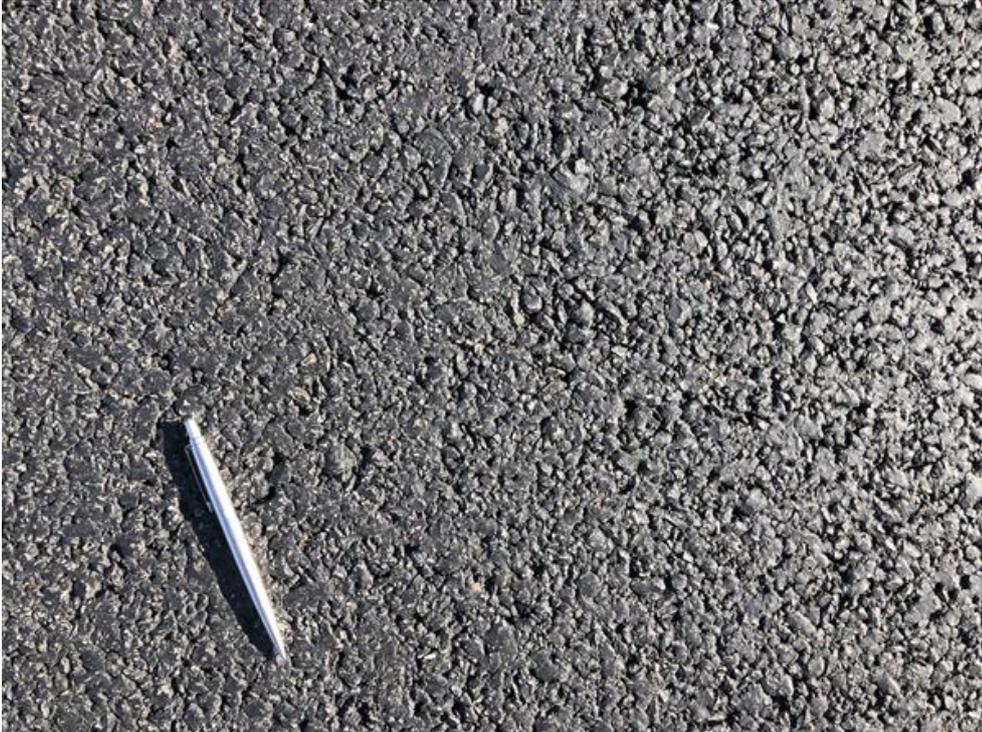
Section 3 of the trial was laid on 17 March 2020, with a crumb rubber asphalt. The mix is a 14 mm gap graded asphalt, utilising C170 binder modified with 18% crumb rubber. An inspection after three months of trafficking found the asphalt to be performing well (Figure 2.5 and Figure 2.6).

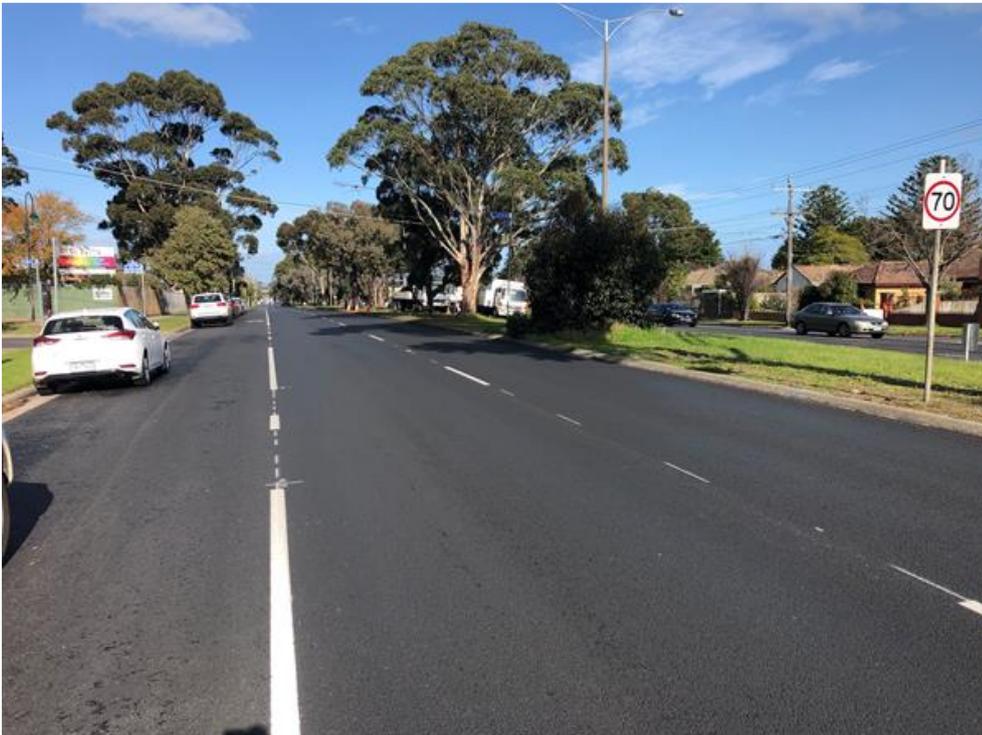
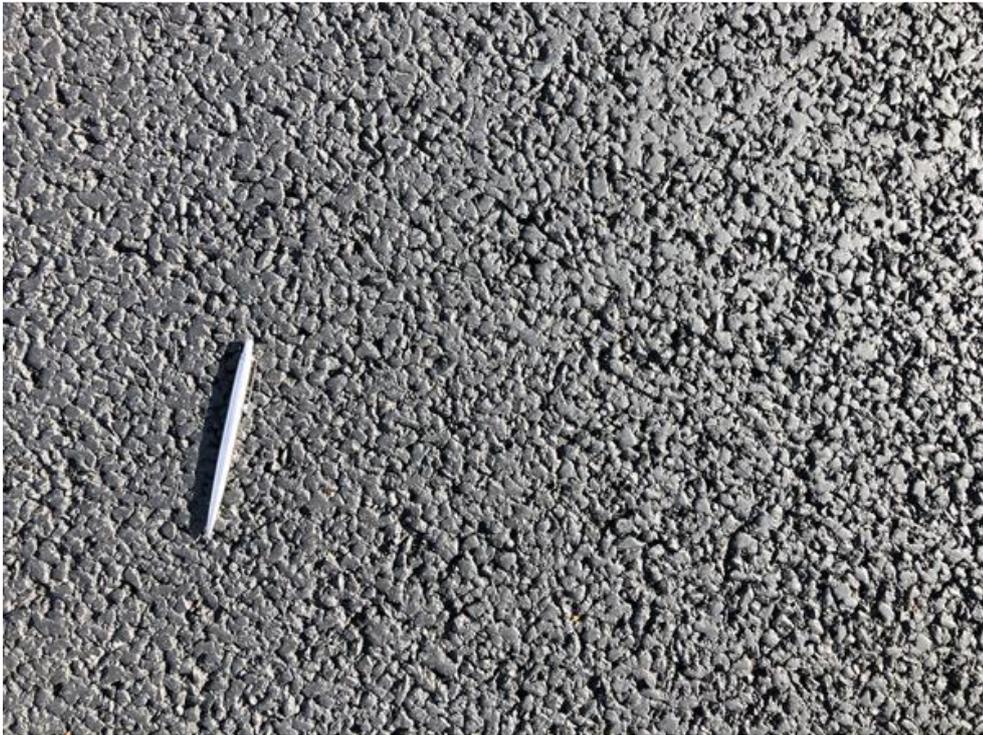
Section 4 of the trial was laid on 18 March 2020, with a crumb rubber asphalt. The mix is a 10 mm stone mastic asphalt, type N, utilising A20E binder that contains 10% crumb rubber. An inspection after three months of trafficking found the asphalt performing well (Figure 2.7 and Figure 2.8).

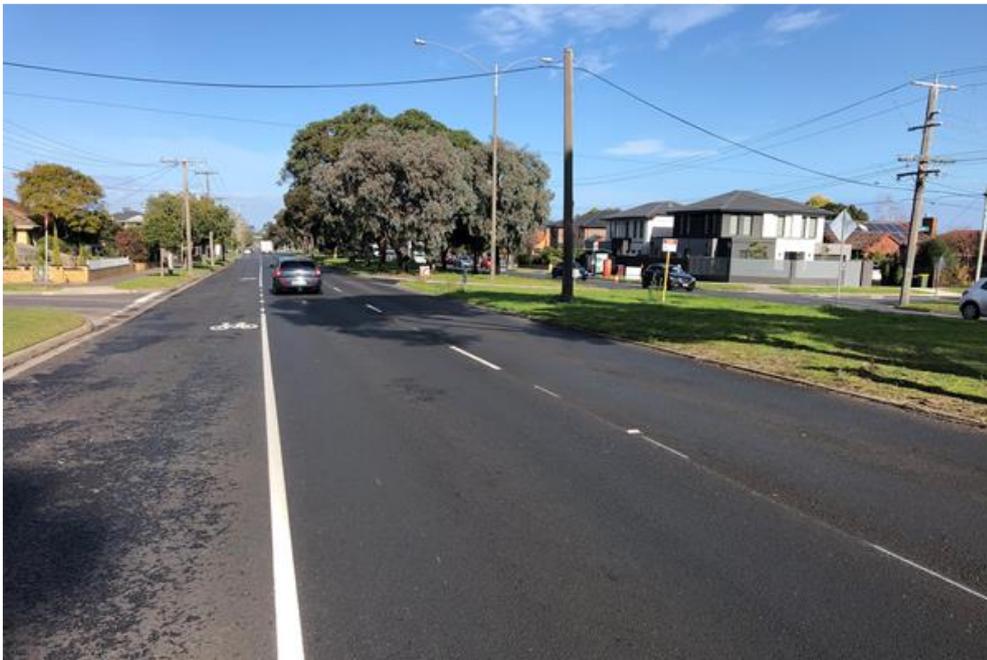
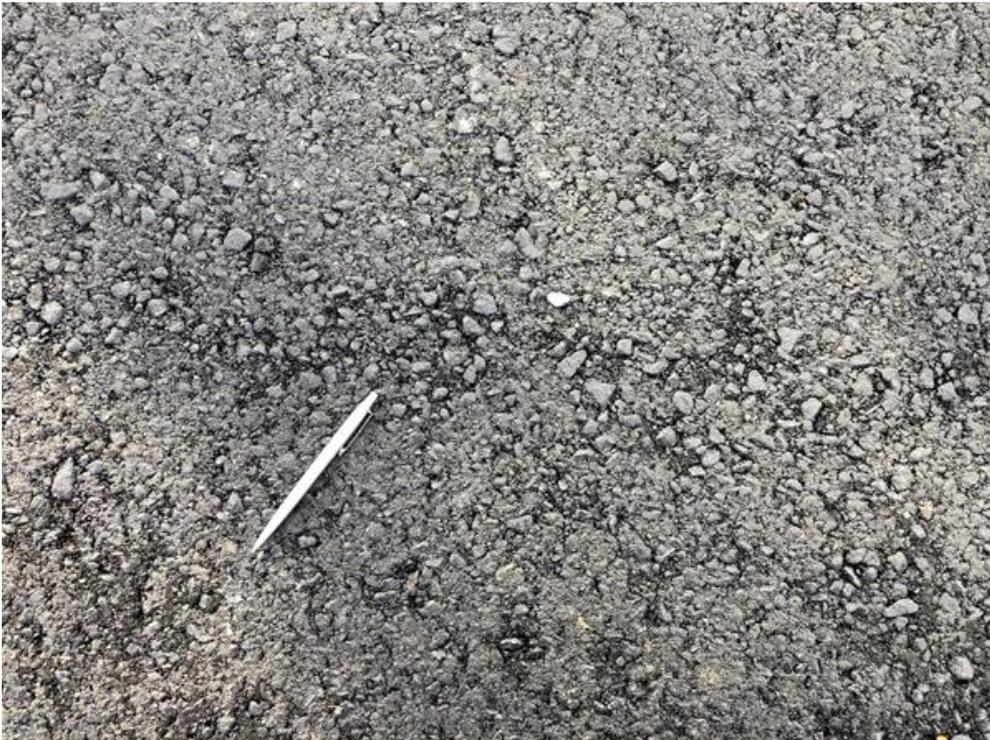
Section 5 of the trial was laid on 22 March 2020, as a control mix (Figure 2.9). The mix is a 10 mm stone mastic asphalt, type N, utilising A20E binder. An inspection after three months of trafficking found the asphalt performing well, with some evidence of dragging from construction early in the section (Figure 2.10).

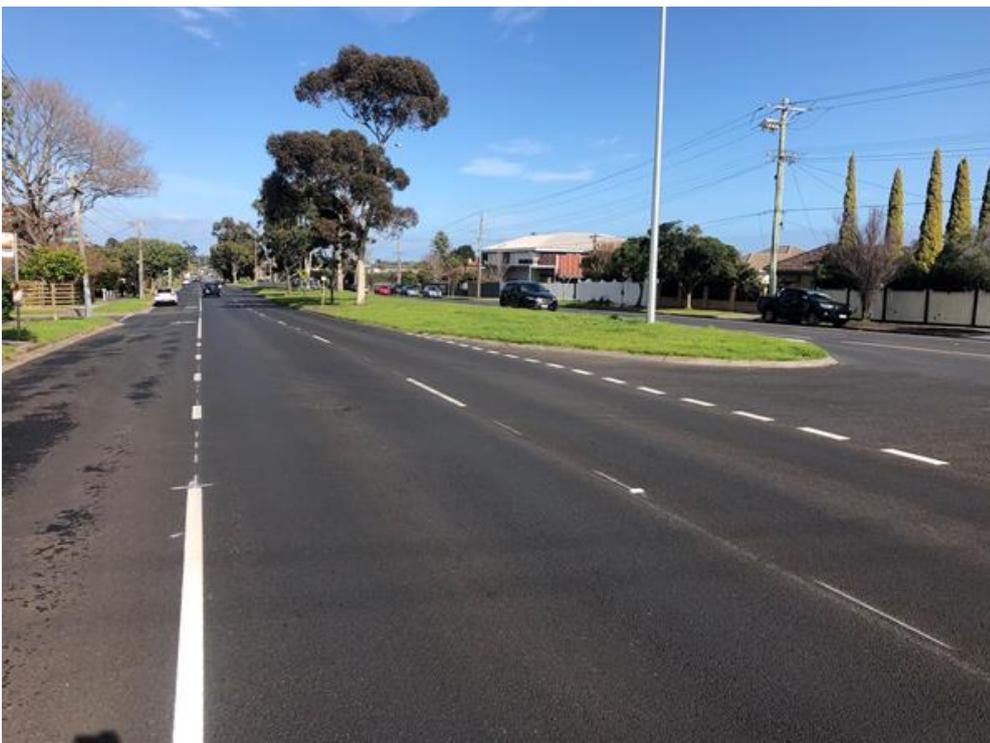
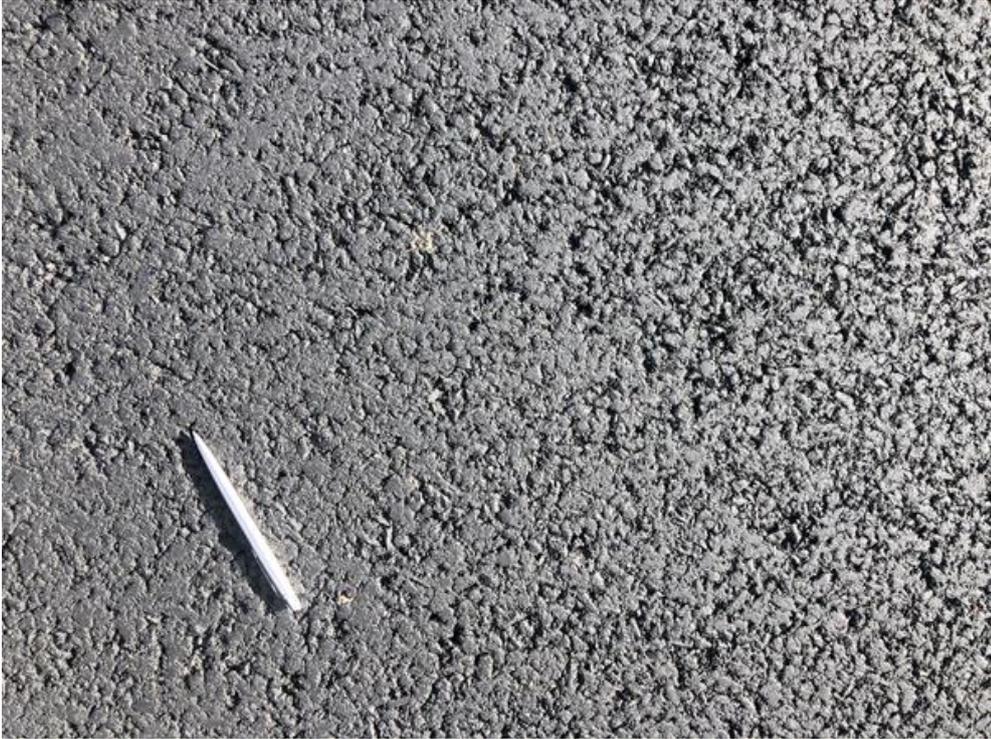
Section 6 of the trial was laid on 23 March 2020, with a crumb rubber asphalt (Figure 2.11). The mix is a 10 mm stone mastic asphalt, type N, utilising A20E binder. This asphalt is a dry mix crumb rubber, with 1% of crumb rubber by mass of mix added. An inspection after three months of trafficking found the asphalt performing mostly well, but with some flushing and loss of texture in the wheelpaths (Figure 2.12).

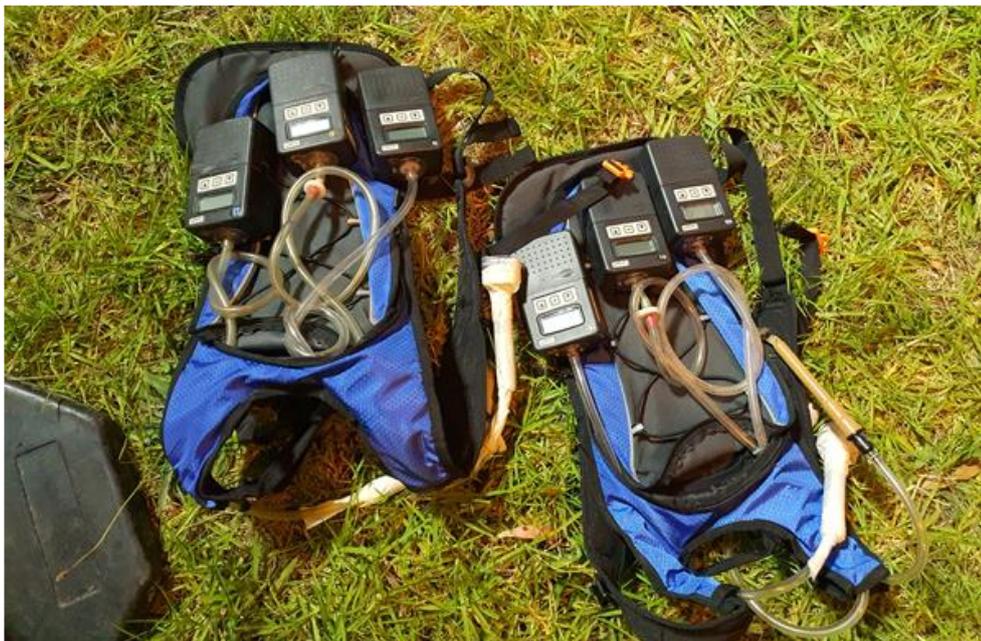
Figure 3.1: Emissions monitoring equipment loaded into backpacks

The monitoring devices were assembled into small backpacks that were worn for the extent of the paving operations by the nominated members of the paving crew (Figure 3.1). The devices were used to collect samples for all the asphalts paved, both crumb rubber asphalts and control mixes, allowing comparison.

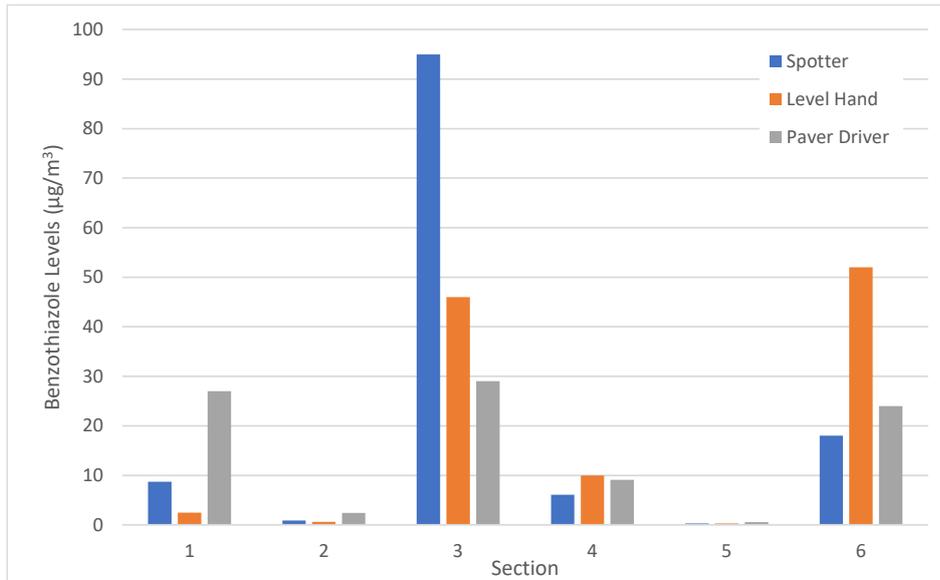
Figure 3.2: Benzothiazole result comparison

Operators' breathing zone concentrations of Benzothiazole were significantly higher when laying CRA (Sections 1, 3, 4, 6) than control SMA mixes (Sections 2 and 5). The results are consistent with those of overseas studies where measurement of benzothiazole exposures have been undertaken on crews undertaking CRA paving, both in terms of exposure patterns (i.e. CRA resulting in approximately 10 times higher exposures to benzothiazole) and the magnitude of the exposures.

The highest breathing zone benzothiazole levels were measured in Section 2 with the spotter having the highest exposure of the three operators monitored. This coincided with reported symptoms of light-headedness and sore throat from the level hand when questioned. The spotter did not report symptoms. The Section 3 CRA had a distinct rubber odour, which was not evident with other CRA mixes.

It is difficult to interpret the results of the monitoring in terms of reported symptoms due to the varied use of respiratory protection, variations in the amount of mix from night-to-night, weather conditions on each night such as air temperature, wind speed and direction, the use of the paver-mounted pedestal fans for some mixes and not others, and the side of the paver that the level hand was operating from (e.g. the level hand operated from the right-hand side of the Paver on 18/3/2020 and on the left-hand side on other nights). However, as symptoms of sore throat and stinging eyes were reported for both the control stone mastic mixes (where benzothiazole levels were low) and some of the trial CRA mixes (with elevated benzothiazole exposures) and no symptoms for other CRA mixes where benzothiazole levels were similar, there did not appear to be a correlation between benzothiazole levels and symptoms in this study.

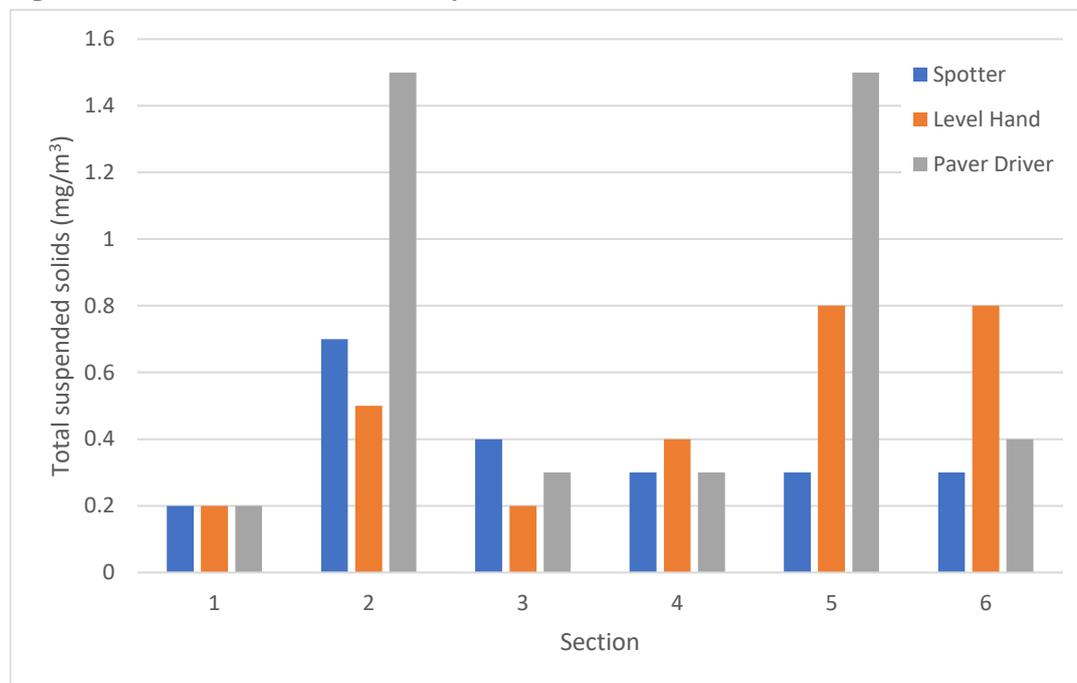
Figure 3.3: Benzothiazole result comparison

All TSP levels were below the SafeWork Australia recommended guideline value for Dusts Not Otherwise Classified (DNOC) of 10 mg/m³ and the AIOH trigger value for DNOC of 5 mg/m³.

The results indicate that the TSP exposure of the three members of the asphalt crew were significantly higher for the two control conventional stone mastic asphalt mixes (range 0.3 mg/m³ to 1.5 mg/m³) than for any of the CRA trial mixes (range 0.2 mg/m³ to 0.8 mg/m³). Previous overseas studies have shown no significant differences in the total particulate exposure levels between crews undertaking conventional SMA and CRA paving operations.

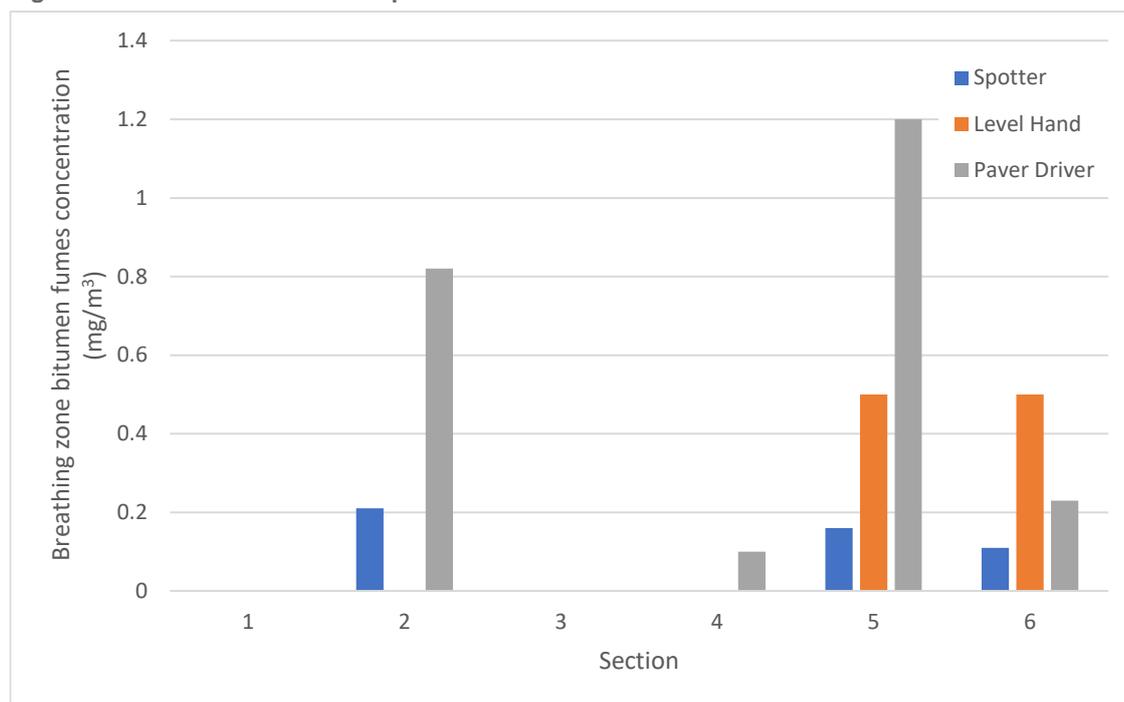
Figure 3.4: Bitumen fumes comparison

The results indicate that the bitumen fume exposure monitoring of the three members of the asphalt crew were generally higher for the two control SAM mixes (Sections 2 and 5) (range 0.16 mg/m³ to 1.2 mg/m³) than for any of the CRA trial mixes (Sections 1, 3, 4, 6) (range < 0.1 mg/m³ to 0.5 mg/m³). Overseas studies have found no significant differences in bitumen fume exposure levels between crews paving with conventional SMA compared with CRA.

Similarly, to the TSP results, the highest bitumen exposure levels were for the paver driver for the control SMA mixes (0.82 to 1.2 mg/m³). This most likely indicates that bitumen fume particles constitute a significant portion of the TSP. Laying of most of the CRA trial mixes had nondetectable to barely detectable levels of bitumen fume exposure, except for Section 6, which showed exposure levels between 0.11 mg/m³ to 0.5 mg/m³. All bitumen fume levels were well below the SafeWork Australia bitumen fume workplace exposure standard over the monitoring period and, when calculated as 8-hour time-weighted average exposures, would be below approximately 10% of the standard.

Bitumen fumes were monitored as they may be irritating to mucous membranes, with symptoms increasing with increasing temperatures of asphalt. The study found that bitumen fume exposure was higher for the control SAM mixes than the CRA mixes, which contrasts with some overseas studies that found no significant difference. However, all bitumen fume levels detected were well below SafeWork Australia standard over the monitoring period, equivalent to below approximately 10% of the standard when calculated as 8-hour time-weighted average exposure.

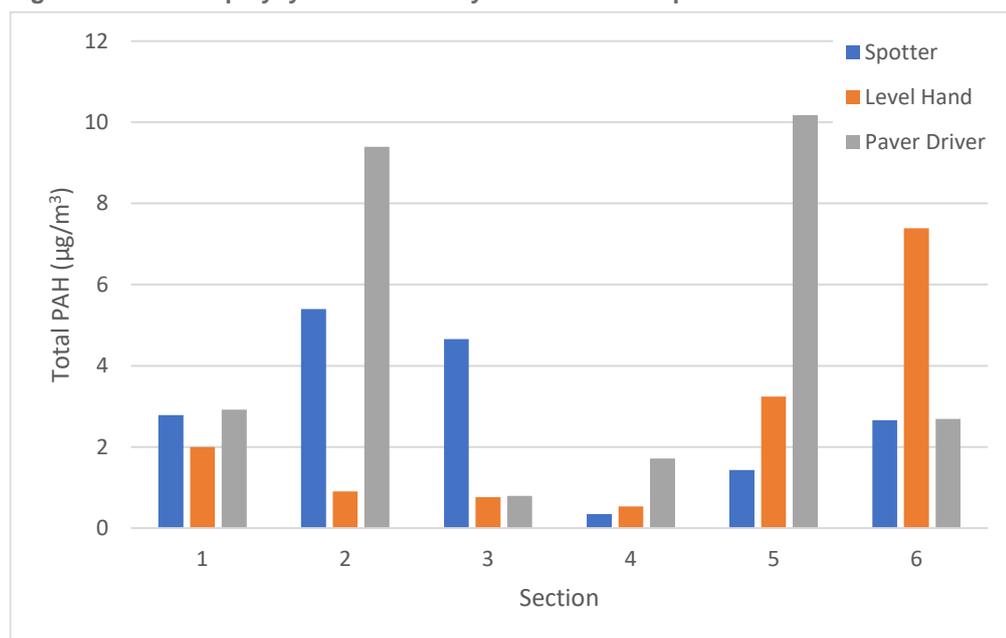
Figure 3.5: Total polycyclic aromatic hydrocarbons comparison

The results of PAH monitoring indicate that the exposure of the three members of the asphaltting crew to total 16 USEPA Priority PAHs were generally higher for the SMA mixes (Section 2 and 5) (range 0.9 µg/m³ to 10.18 µg/m³) than for any of the CRA trial mixes (Sections 1, 3, 4, 6) (range 0.34 µg/m³ to 7.39 µg/m³). This contrasts with the results of previous studies, and may reflect the slightly higher average temperatures of the control SMA mixes compared with the CRA trial mixes and the variations on weather conditions. The paver driver showed the highest median PAH exposures over all the trials of the three crew members tested, followed by the spotter and then level hand. It should be noted that all three operators were smokers and therefore there is a potential contribution of PAH exposures from smoking in addition to that from asphalt fume exposure.

Naphthalene (a non-carcinogenic and the most volatile PAH) was the most prominent PAH with the highest levels measured being 6.6 µg/m³ for the paver driver during laying of Section 2, and 3.2µg/m³ for Section 6. All levels of naphthalene were well below the SafeWork Australia workplace exposure standard of 52 mg/m³

PAHs are widespread in the environment, and several are known to be potential carcinogens. PAHs present in bitumen may be exposed to crews during paving. The study found that PAHs were generally higher for the SMA mixes than for the CRA mixes. This contrasts to previous studies that have found similar or higher levels of PAH for CRA compared to SMA, and may reflect the slightly higher paving temperatures of the SMA and variations in weather conditions. The most prominent PAH detected was naphthalene, but at a level well below SafeWork Australia standards. The major PAH compounds detected are not classified as carcinogenic. Both SMA sections and one CRA section showed detectable levels of benz(a)anthracene (a carcinogenic PAH), however the most carcinogenically potent PAH benz(a)pyrene was not detected in any of the samples for either the SMA control or CRA trial mixes.

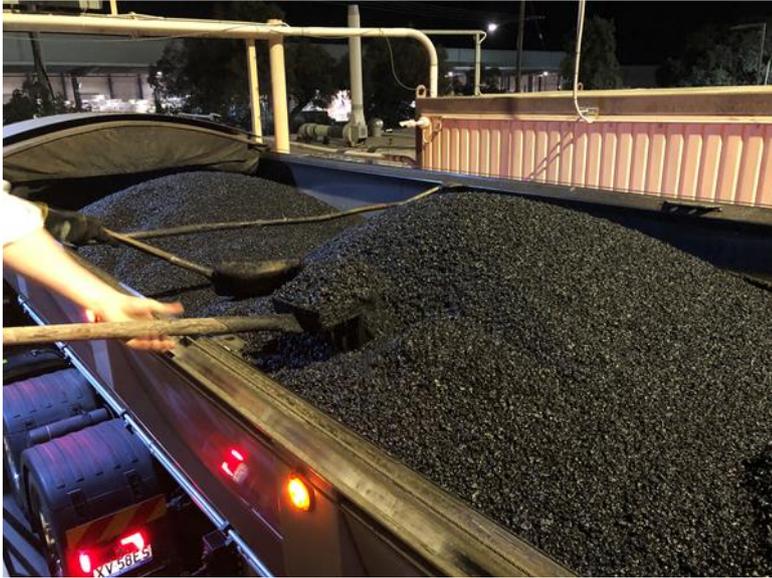
Figure 4.1: Collecting crumb rubber asphalt samples

Samples of each trial asphalt mix were collected at the plants from the delivery truck at the time of production, as they were being prepared for delivery (Figure 4.1).

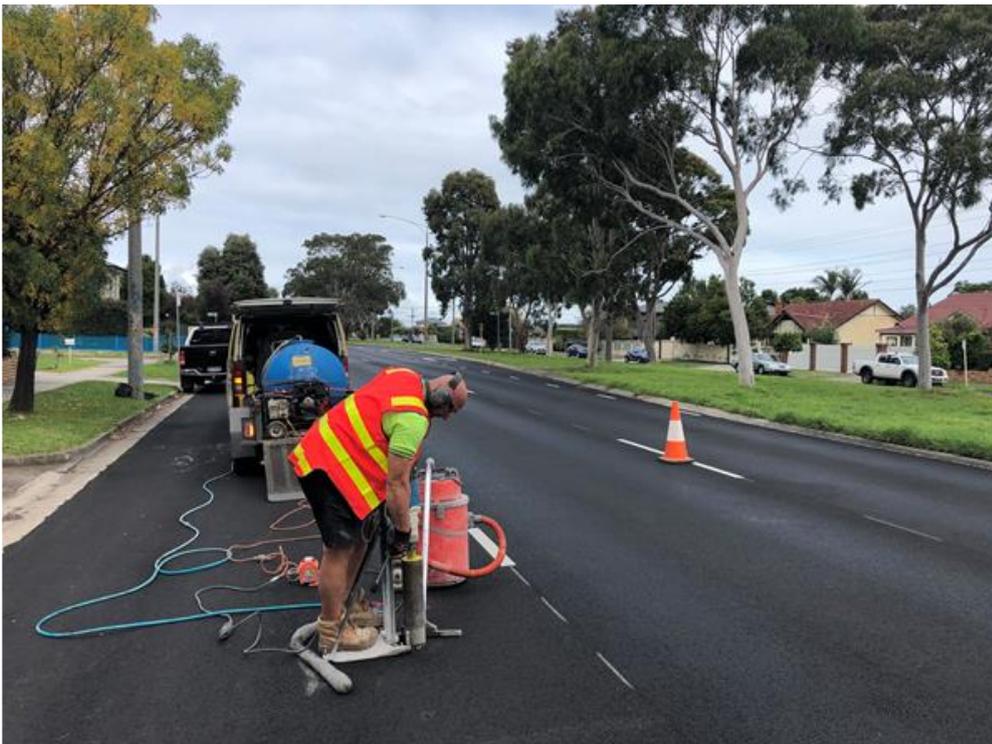
Figure 4.2: Extracting cores from completed trial sections

Asphalt cores were collected (Figure 4.2) from the paved asphalt sections to verify layer thickness and test the strength capabilities in situ.

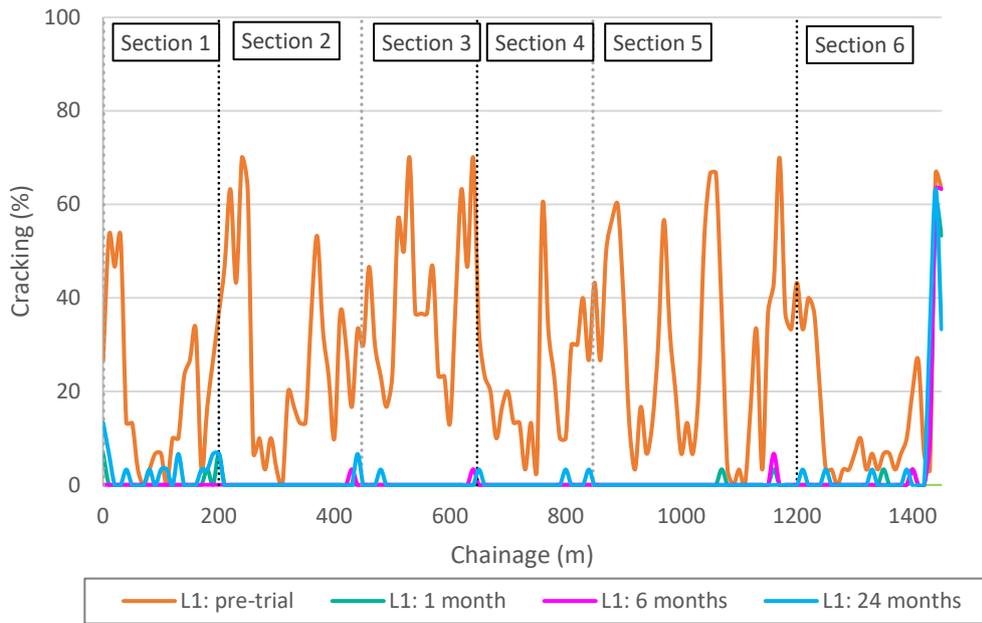
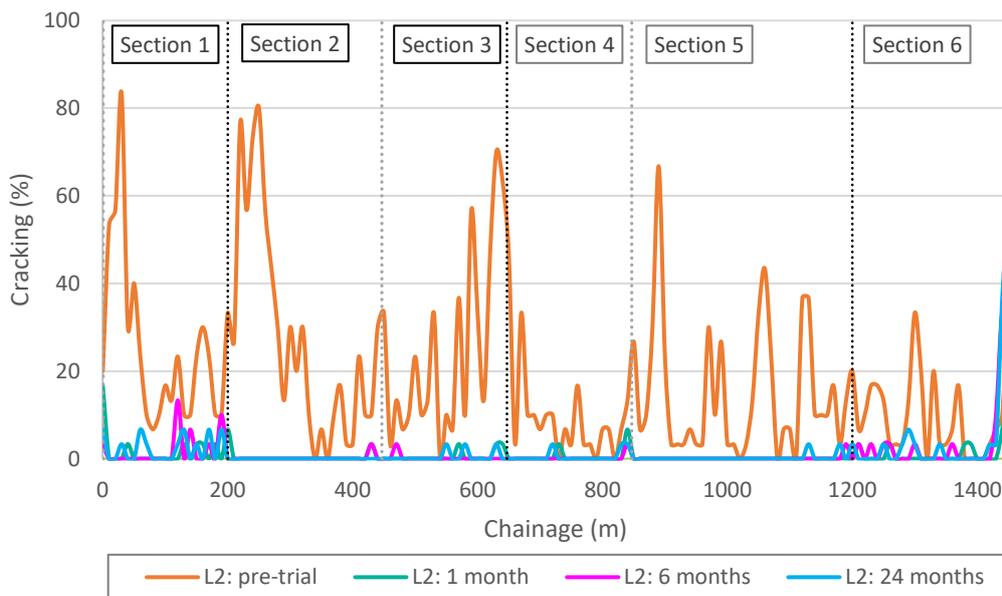
Surface cracking throughout the site was measured by the ARRB NSV. Results for Lane 1 are shown in Figure 5.1, and Lane 2 in Figure 5.2.

Pre-trial, the cracking was consistent throughout the site. At one month after the trial, the new surface has eradicated the surface cracking, however the automatic crack detection software reported small, isolated areas of cracking, which is mostly noise due to surface changes, and drainage access and other facilities that have made a blemish on the regularity of the surface. The 6- and 24-month surveys returned similar results, with minimal cracks, later confirmed during the site inspection to be noise from other features that the automatic crack detection software mistook as cracking.

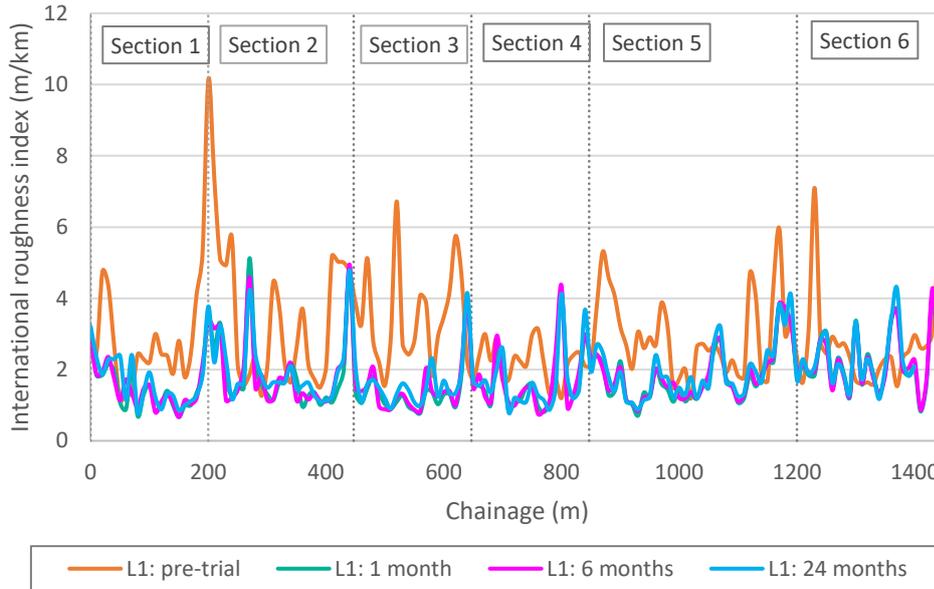
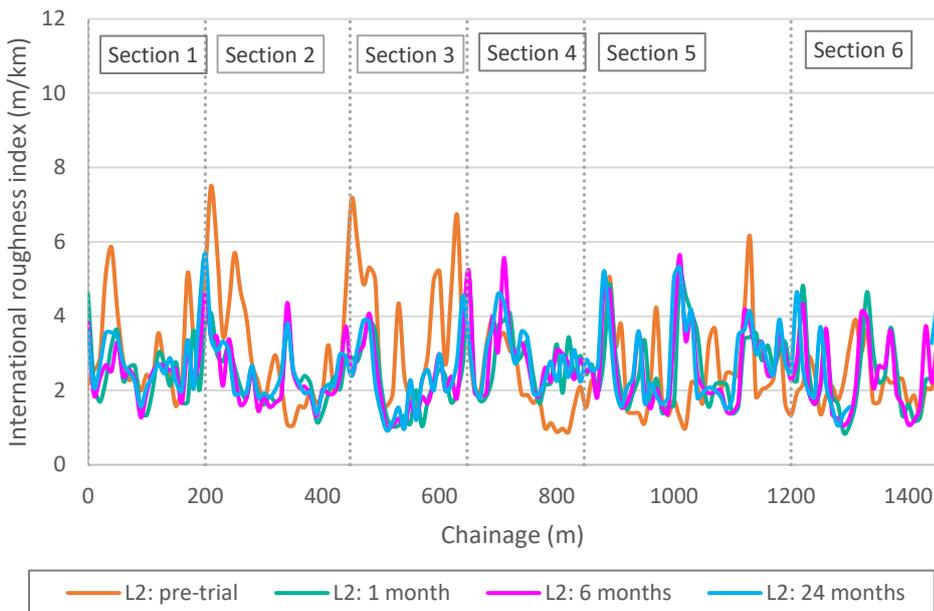
Roughness is an expression of pavement surface irregularities that adversely affect the ride quality of a vehicle and is measured by the ARRB NSV and expressed in terms of the International Roughness Index (IRI). Results are provided for Lane 1 (Figure 5.3) and Lane 2 (Figure 5.4).

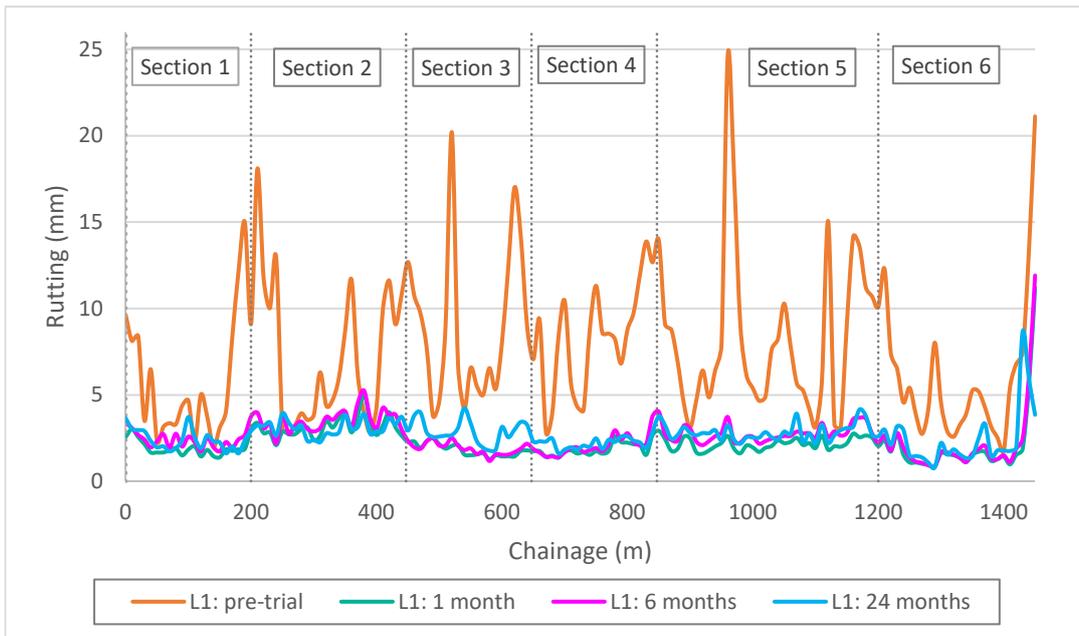
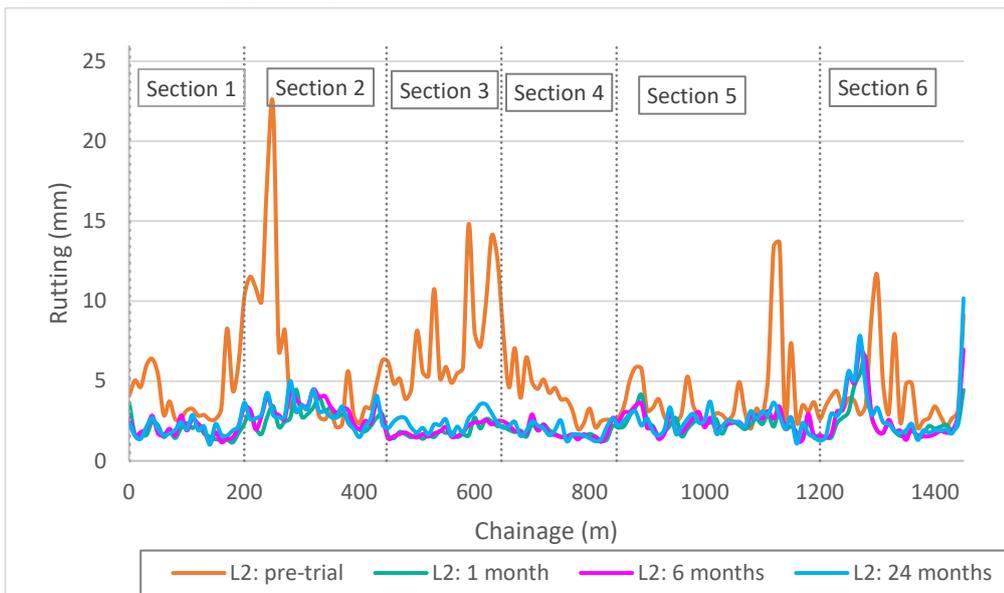
The rutting (left wheelpath) is measured by the ARRB NSV. Results for Lane 1 (Figure 5.5) and Lane 2 (Figure 5.6) are shown.

The new surface has considerably reduced the amount of rutting throughout the extent of the trial sections and has not progressed between the 1 and 24-month surveys, excepting in Section 3 where small ruts appear to be developing, more so in Lane 1, where the inspection noted flushing at the surface (Section 5.3.3).

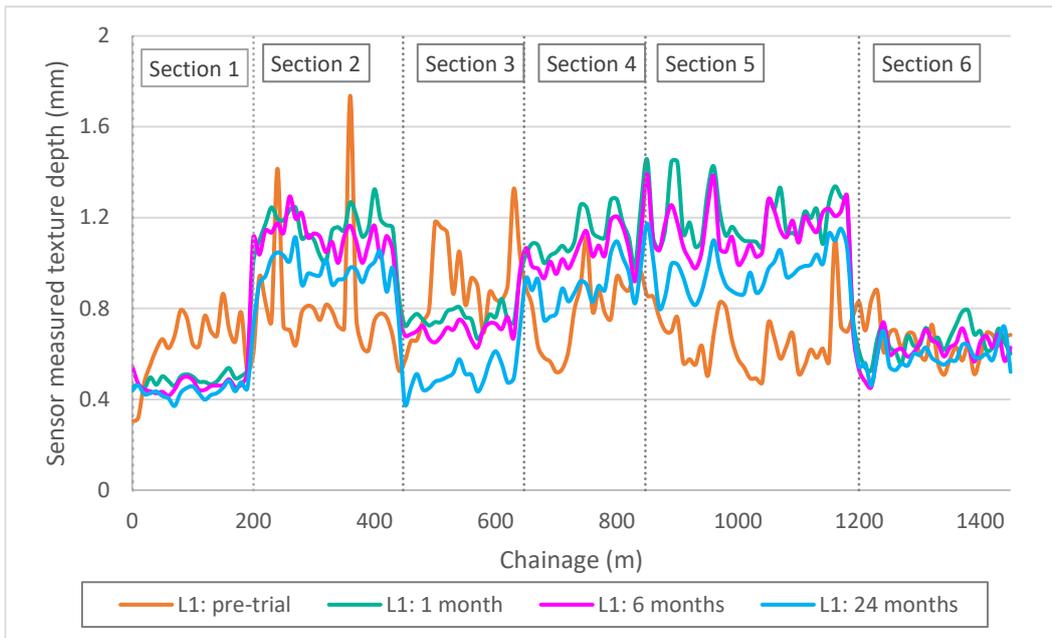
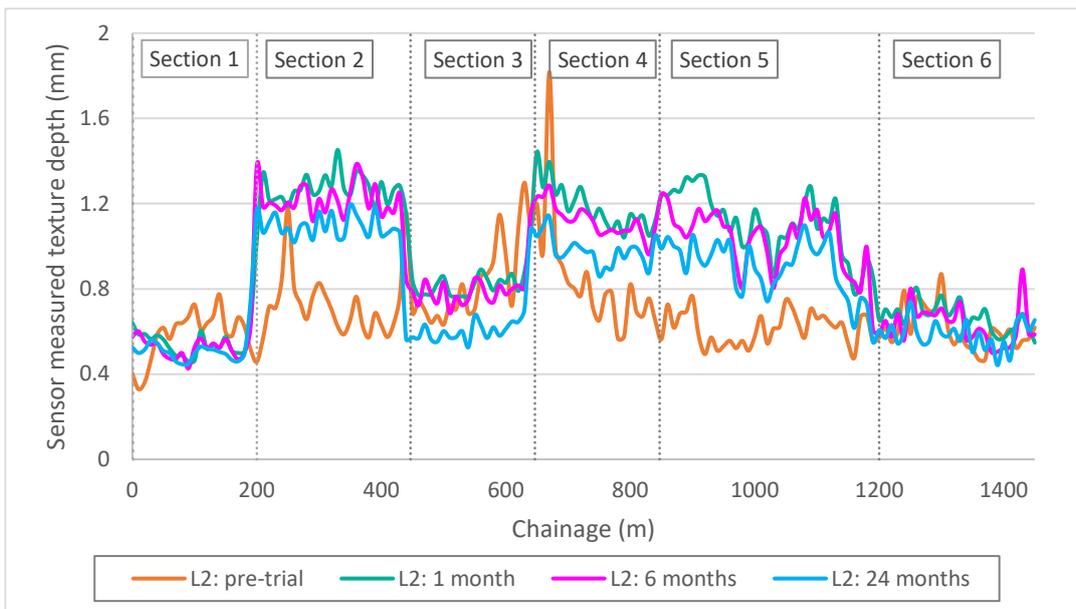
The texture of the surface was measured by the ARRB NSV, and is expressed in terms of sensor measured texture depth (SMTD), and is displayed for the left wheel paths in Lane 1 (Figure 5.7) and Lane 2 (Figure 5.8).
