Crumb Rubber Asphalt Demonstration Trials – Final Report

ARRB Project No.: 014173

Prepared for: Tyre Stewardship Australia

May 2022

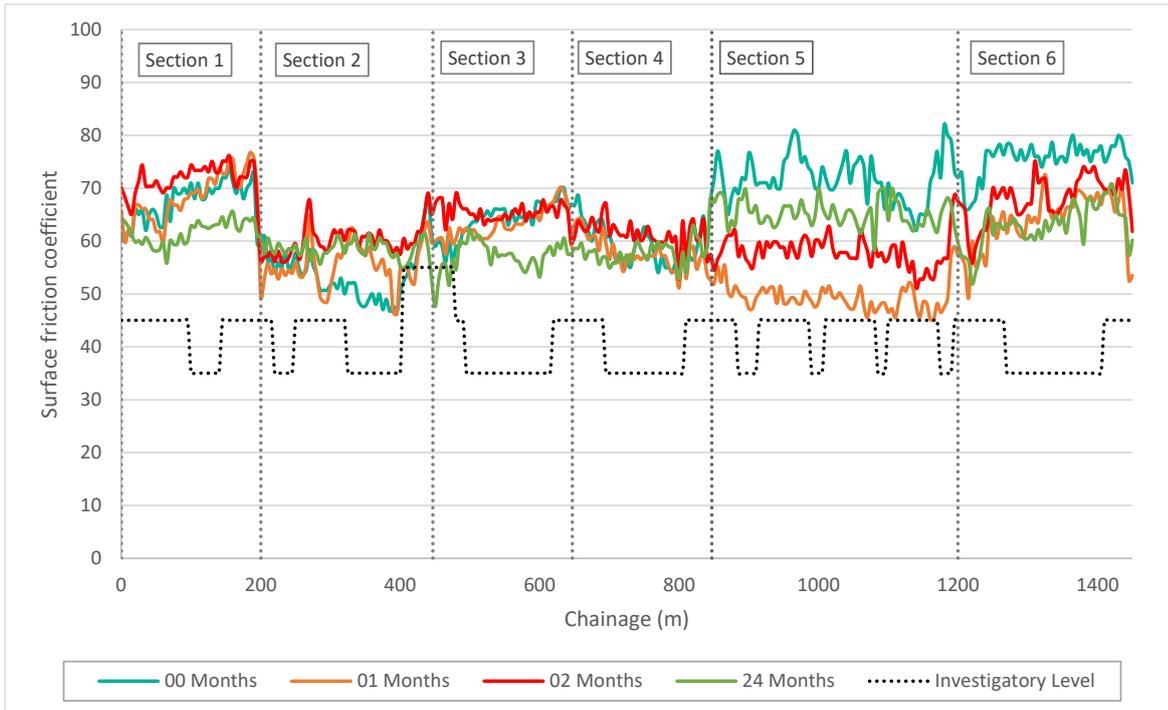
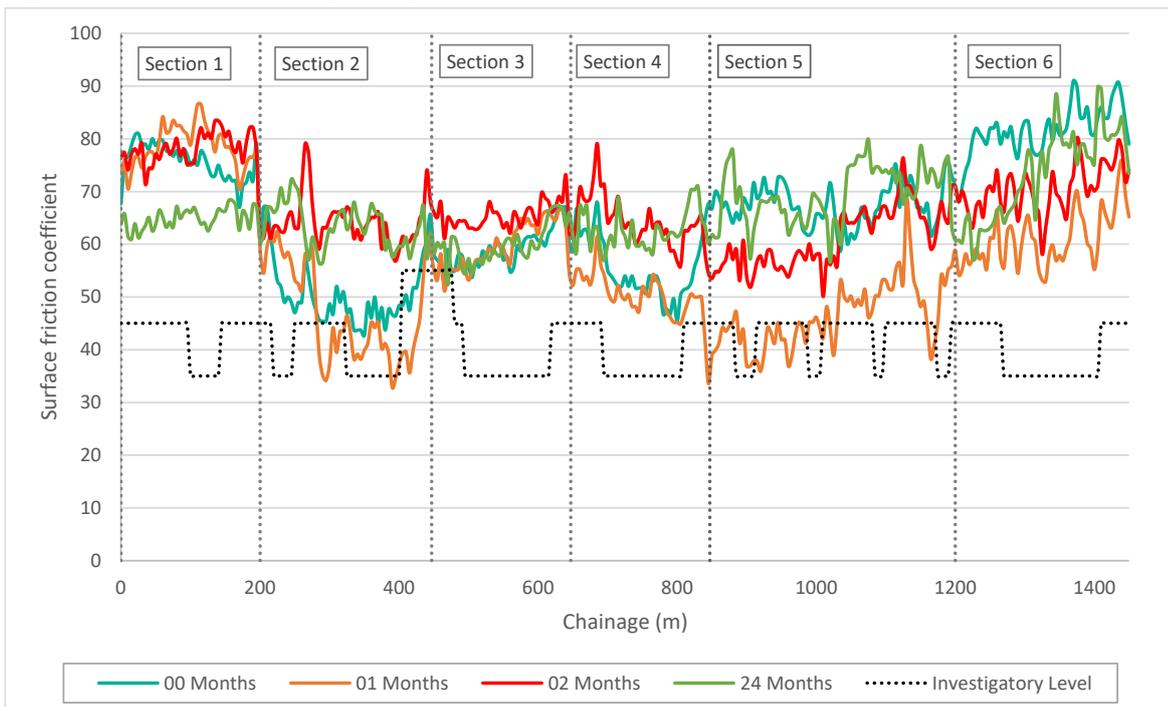
The skid resistance capabilities of the trial asphalts have been measured by the DoT Sideways-force Coefficient Routine Investigation Machine (SCRIM) immediately after the trial, and again after 1 and 2 months. The results for Lane 1 are displayed in Figure 5.9, and Lane 2 in Figure 5.10.

The results show some settling of the asphalt surface over its initial life. In trial Sections 1 through 4, the skid resistance has slightly increased after 2 months, likely due to binder film over aggregate particles on the surface being removed by the scrubbing effect of passing vehicle tyres, which improves the ability of tyres to grip to the surface. After 24 months, the skid resistance has reduced a little throughout Section 1 and Section 3. The skid resistance dips below the DoT investigatory level at the beginning of Section 3, where the inspection noted flushing at the surface (Section 5.3.3).

After 1 month, the skid resistance reduced considerably in Section 5 and 6 but was somewhat restored after 2 months. It is unclear what caused this, but may be due to some flushing of binder from the asphalt to the surface, which in turn was removed by the scrubbing effect of passing vehicle tyres, which has seen the skid resistance increase again after 2 months. At 24 months the skid resistance had continued to increase in Section 5, and has settled in Section 6.

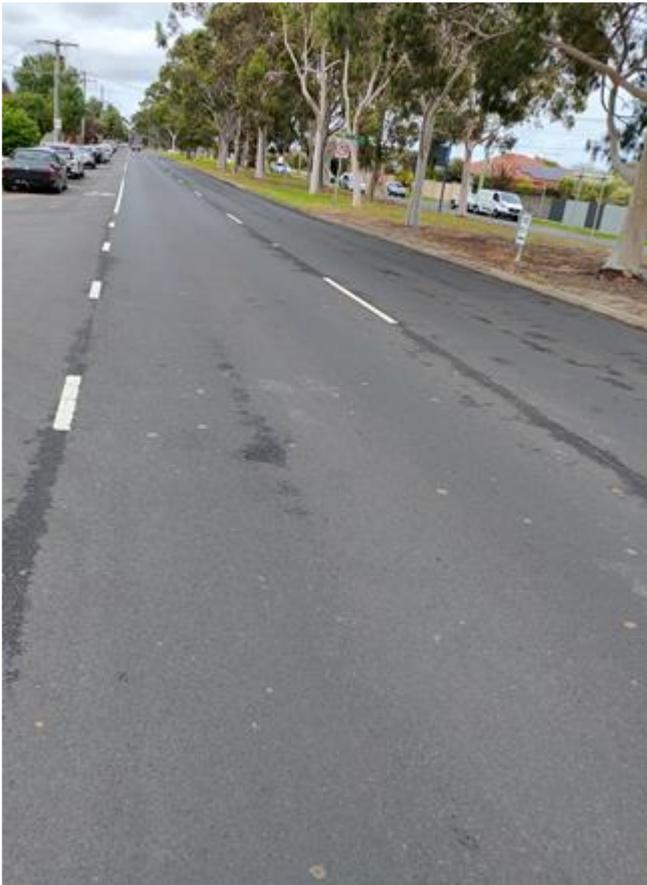
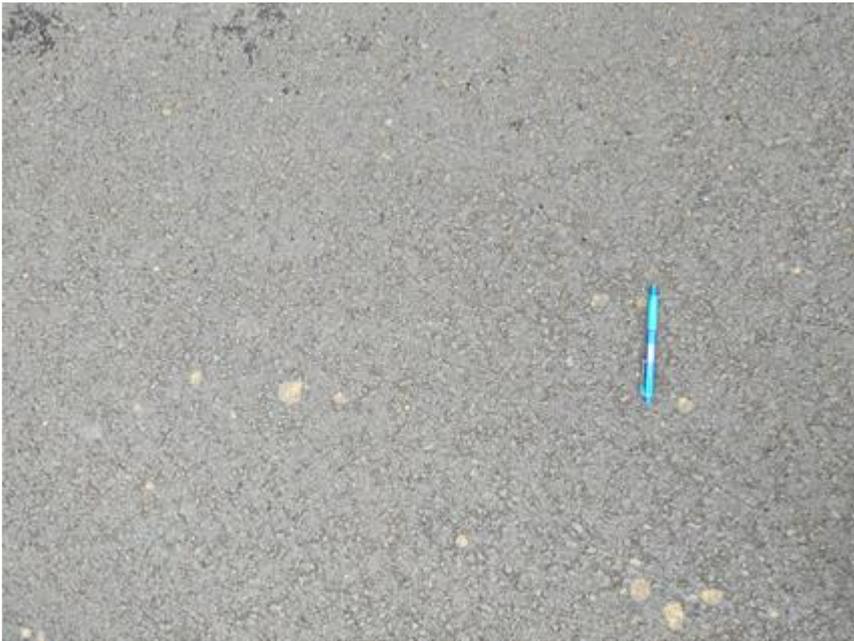
Section 1 was observed to be performing well. In general, the surface appearance is typical of a DGA, albeit slightly coarse (Figure 5.11). There are isolated areas where the texture is bonier, or open, mostly occurring in Lane 2, with Lane 1 in general with a more complete smooth finish (Figure 5.12). There was no apparent ravelling or shape loss.

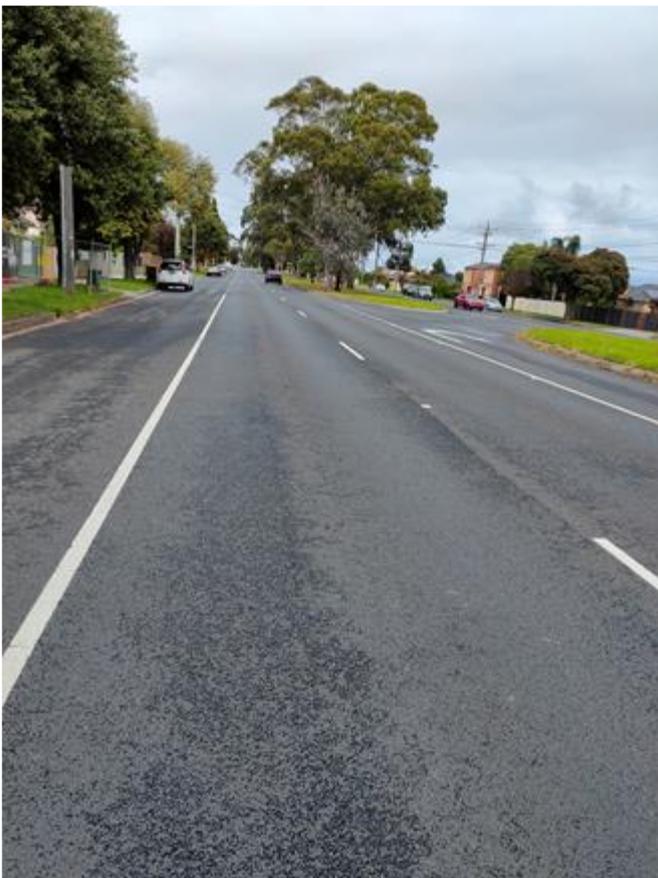
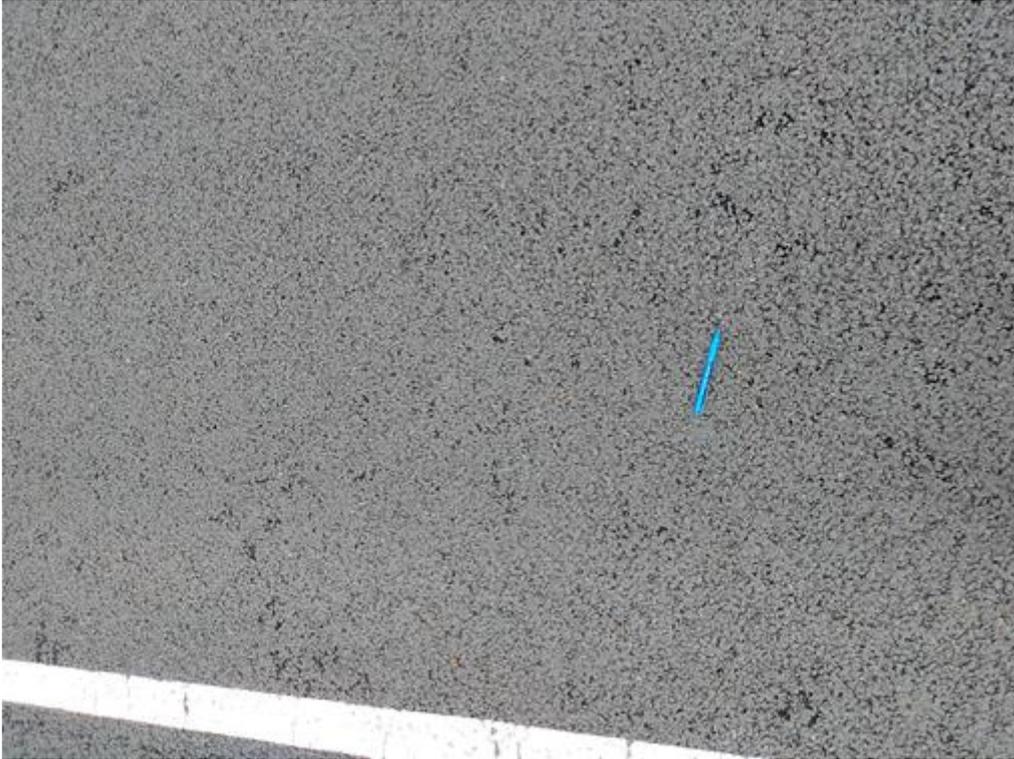
Section 2 was observed to be performing well (Figure 5.13), with a reasonable texture and an appearance typical of an SMA-H asphalt (Figure 5.14). There was no apparent ravelling or shape loss.

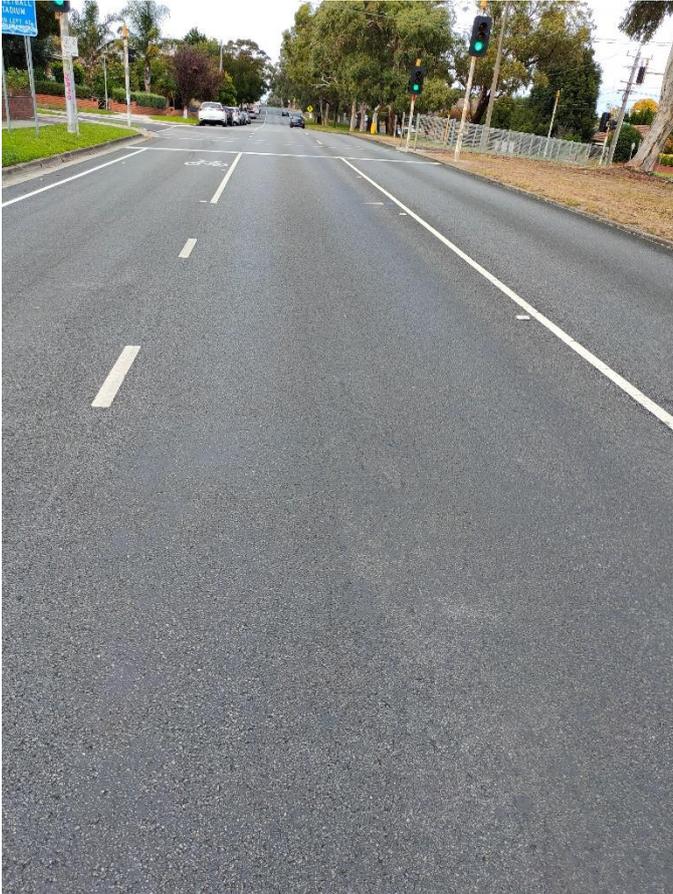
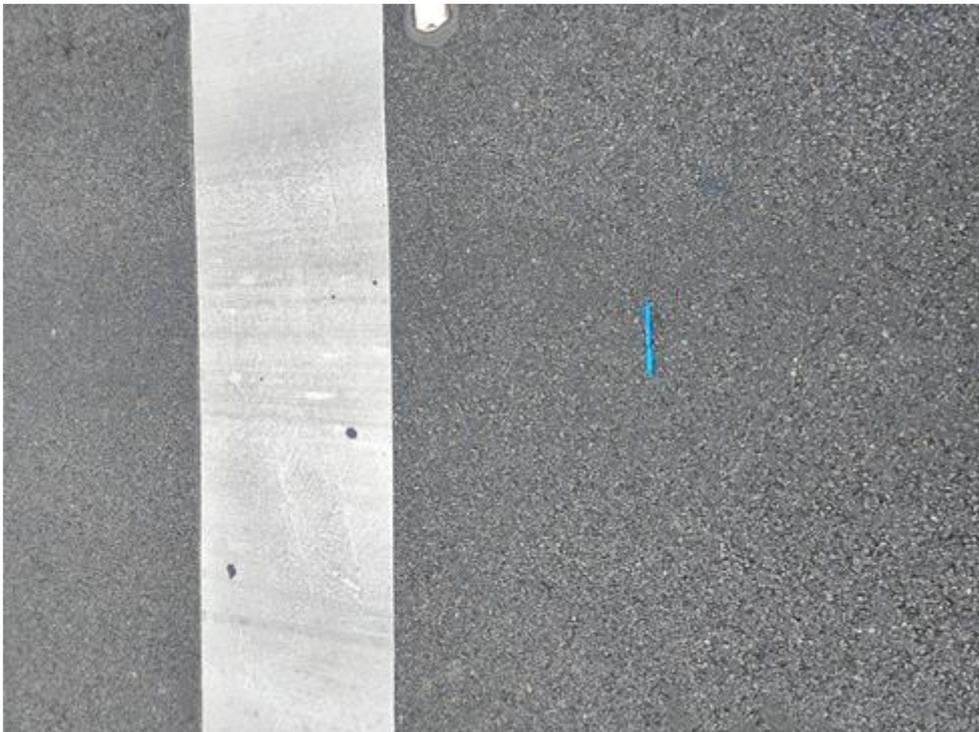
Section 3 was observed to have a good appearance in general (Figure 5.15), with a tight texture appropriate for a GGA. There is flushing developing in the braking and acceleration zone surrounding the pedestrian operated signals, which is worse in Lane 1 (Figure 5.16) but also present in Lane 2. This area of flushing aligns with the small amount of rutting that was measured in the NSV survey at 24 months (Figure 5.5 and Figure 5.6). The rutting had not progressed to a point where it was detectable during the visual inspection. No ravelling was observed.

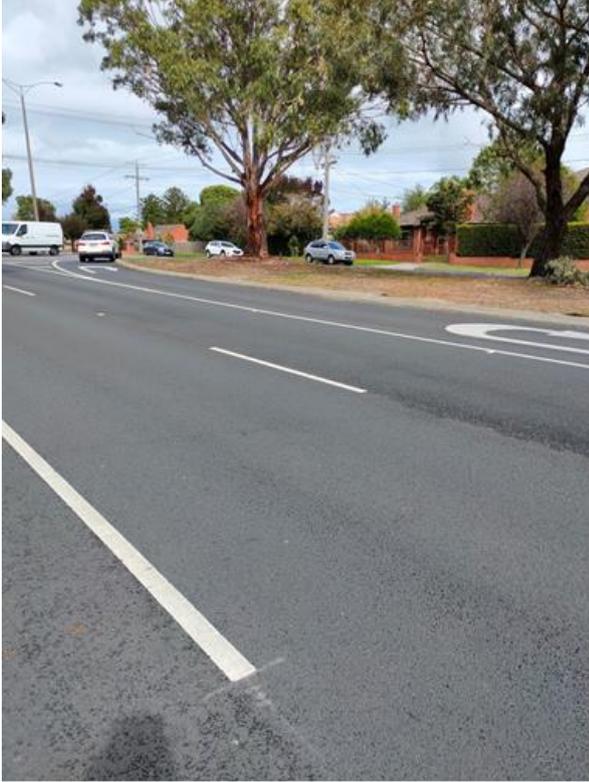
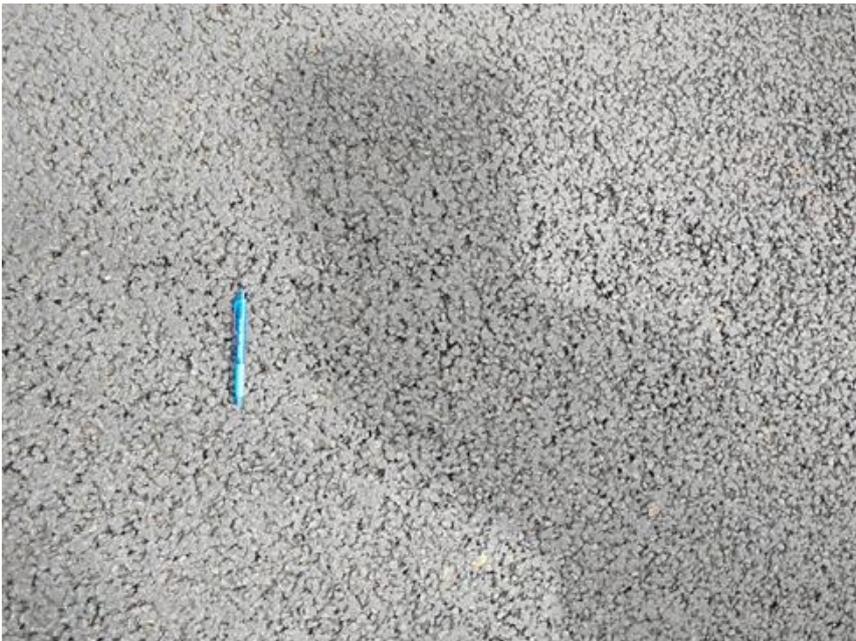
Section 4 was observed to be performing well with a good appearance, typical of a SMA (Figure 5.17). The texture is consistent throughout (Figure 5.18), and there is no evidence of ravelling or shape loss.

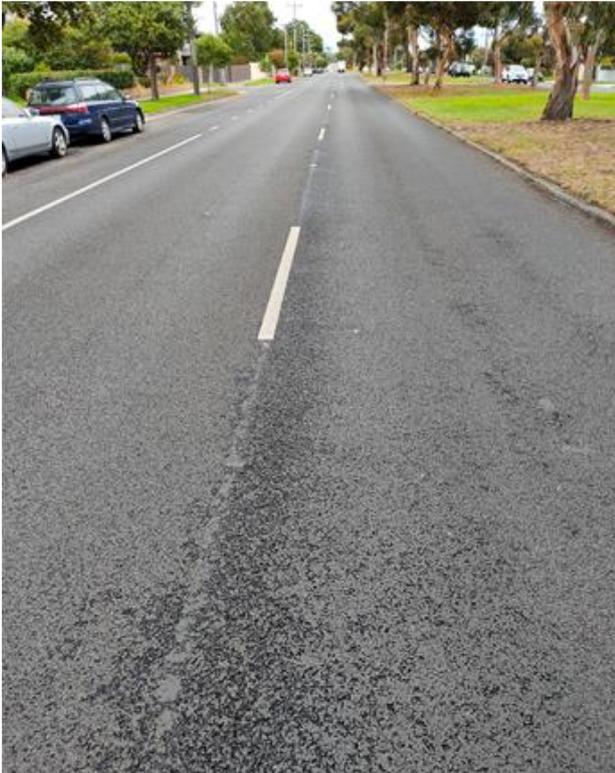
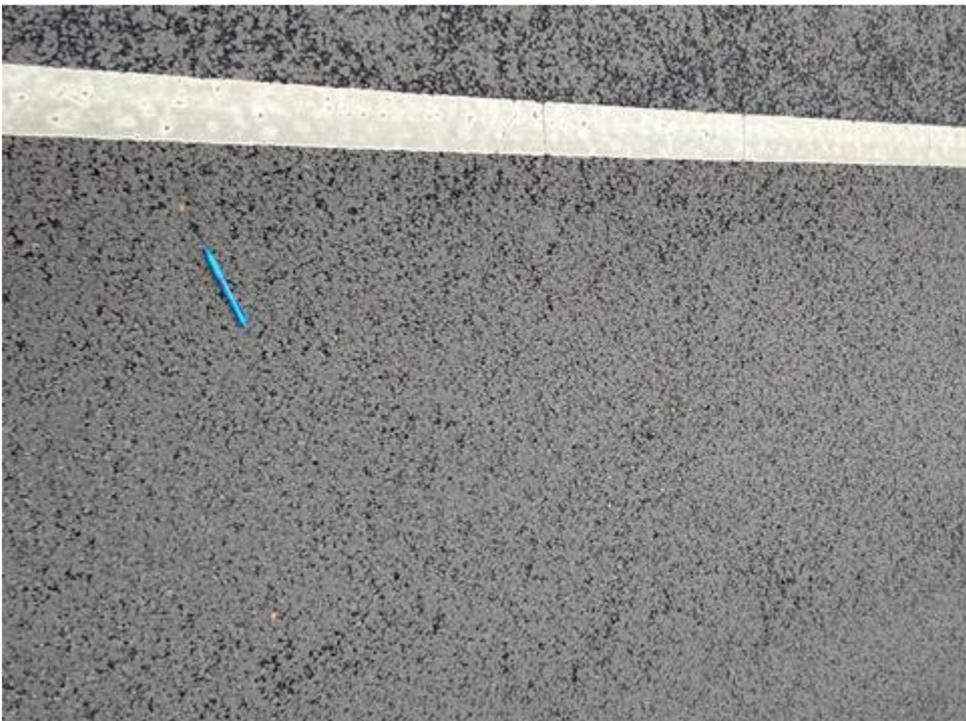
Section 5 was observed to have a good overall appearance (Figure 5.19), typical of an SMA, with isolated areas of open texture in the outer wheelpath of Lane 2. The texture is otherwise consistent throughout (Figure 5.20). There was no ravelling or shape loss detected.

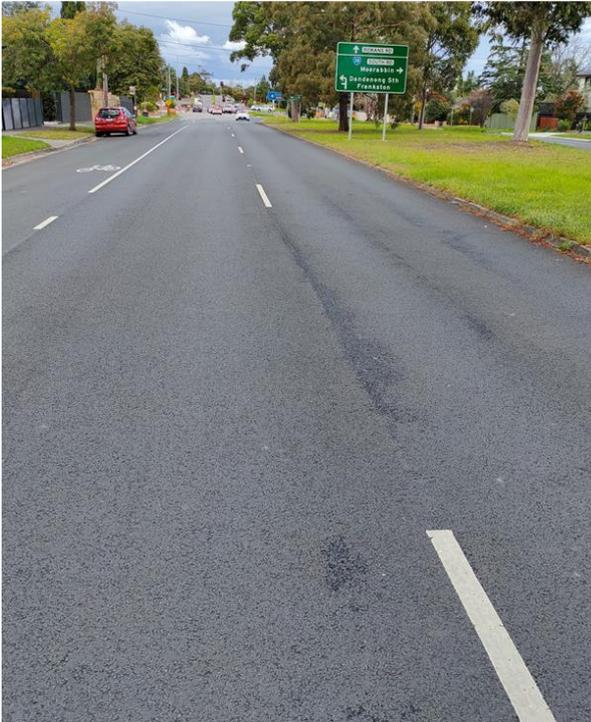
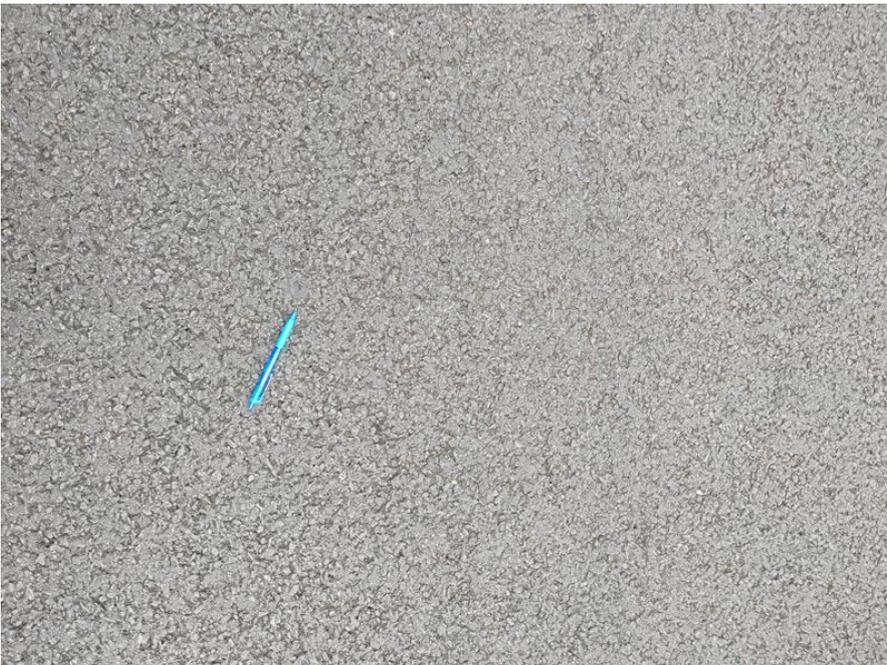
Section 6 was observed to have a generally good appearance (Figure 5.21). The texture was judged to be a little tighter than is typical for an SMA (Figure 5.22), with some more open areas at the start of the section, becoming more consistent towards the end. There was no ravelling or shape loss detected.
